INVESTIGATION  
OF A  
STEEL HIGHWAY BRIDGE

BY  
CHARLES ELLIOTT HENDERSON

THESIS  
FOR  
DEGREE OF BACHELOR OF SCIENCE  
IN  
CIVIL ENGINEERING

The Gilbert Street Bridge,  
Hanville, Illinois,

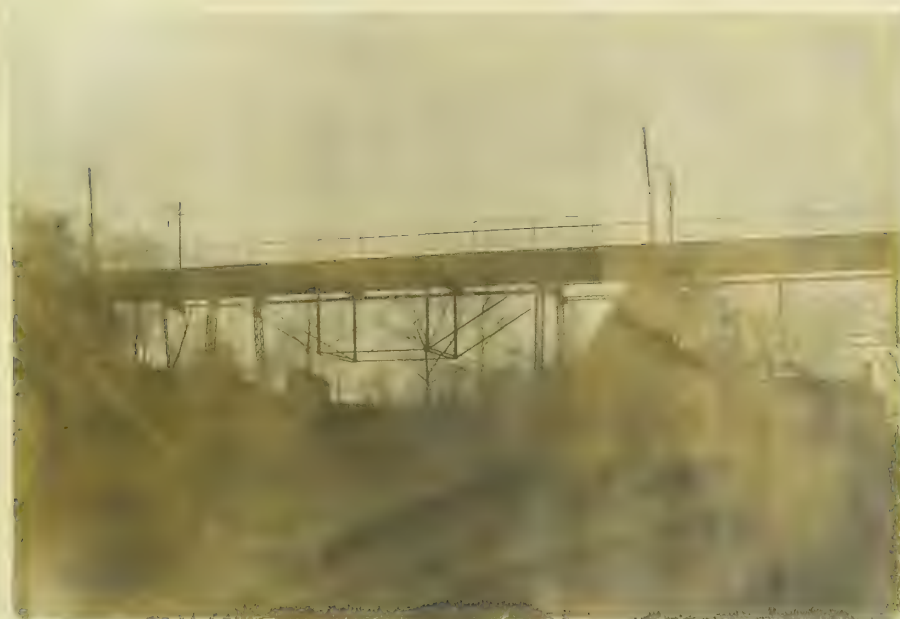
*View No. 1.*

*View of the extreme south end of the bridge,  
showing the two bents, tower, all of first 60-foot Pratt  
truss, and part of the second.*

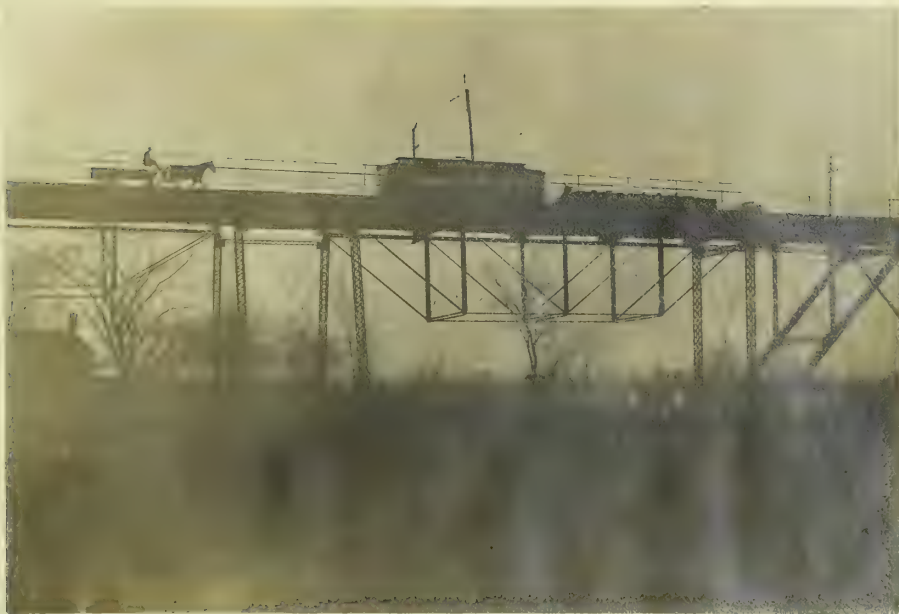
*View No. 2*

*View near south end showing part of second  
60-foot Pratt truss, the second tower, the 80-foot  
Pratt truss, and part of the Warren truss.*

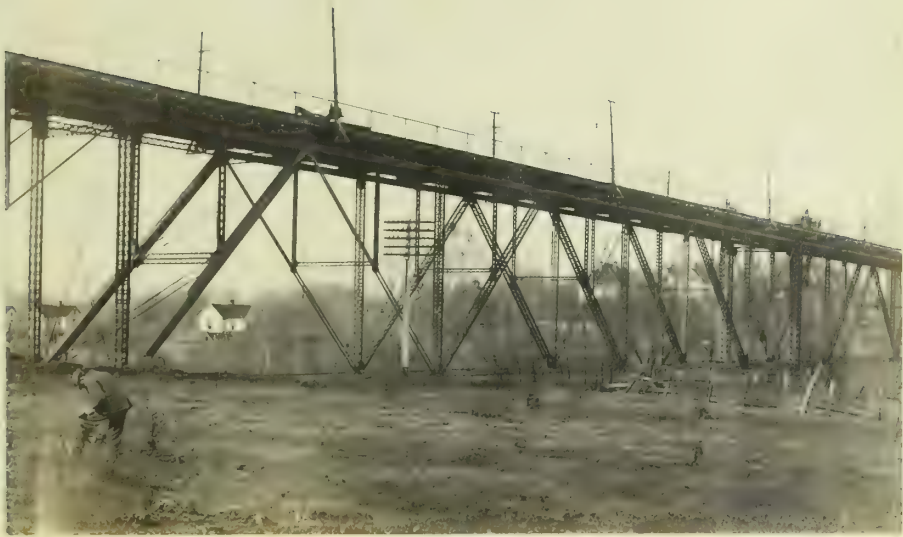
*View No. 3*

*View of the south long span (Warren truss),  
and the center pier.*

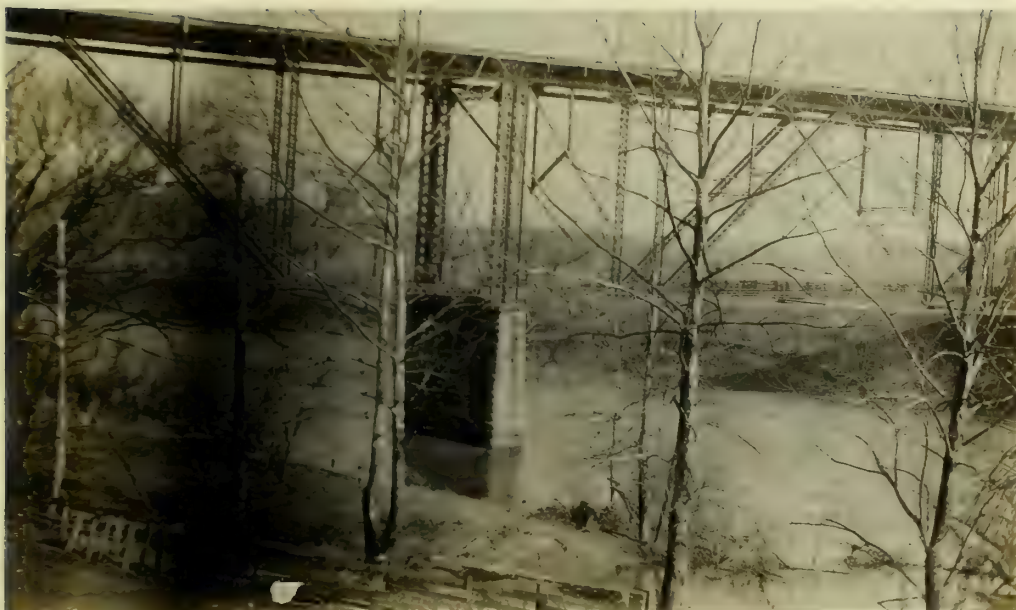
*View No. 4.*

*Center pier supporting skew ends of long spans.*

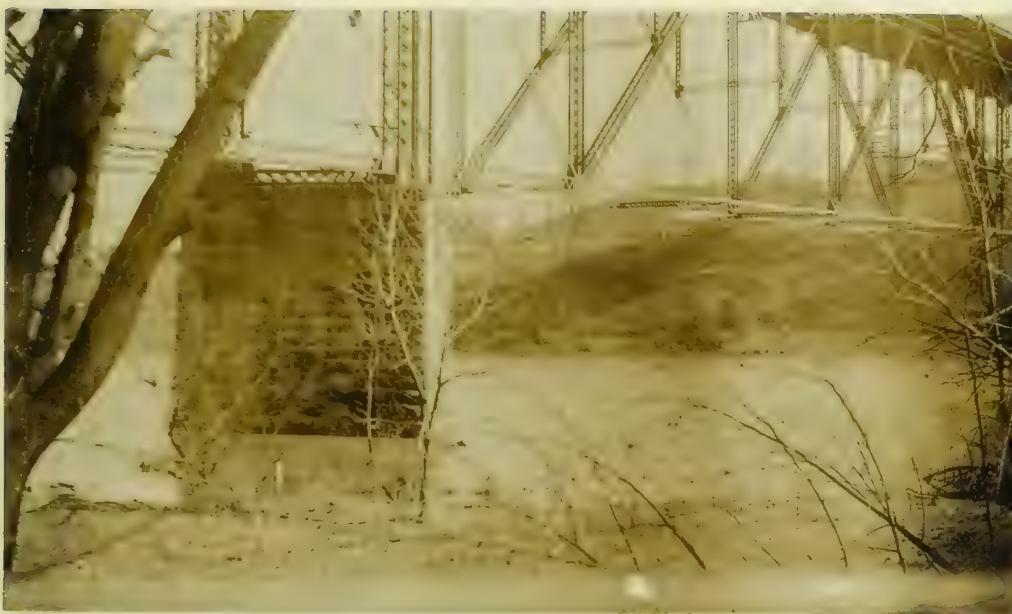
*View No. 5*

*Near view of the center pier.*

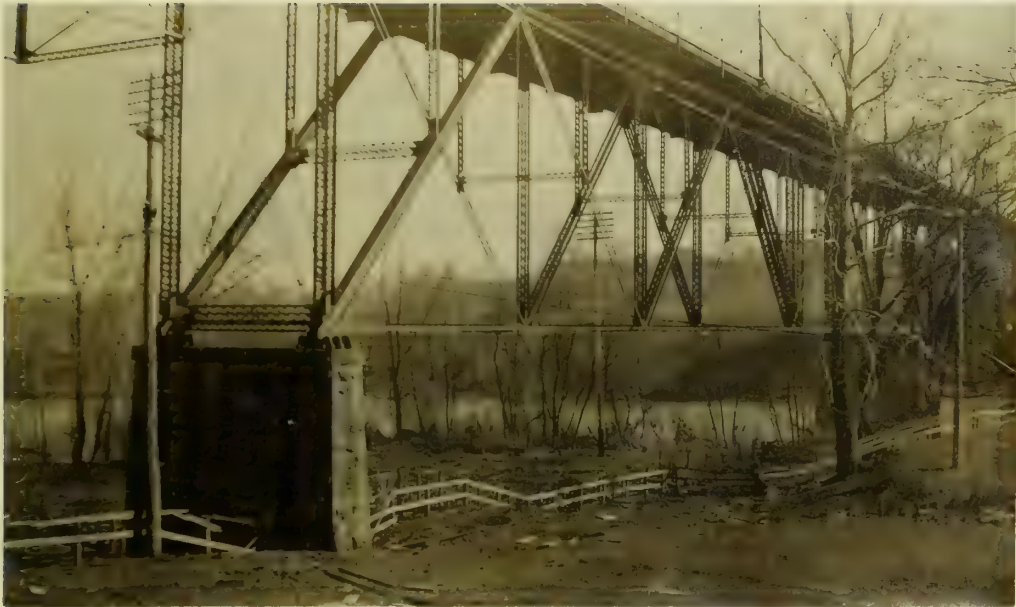
*View No. 6*

*The North long span and the pier supporting  
the north end of the same span.*
